# Site Analysis and Visual Impact Assessment

## Seppeltsfield Tourist Accommodation

Prepared for Intro

Project Number  
319-0618-00-L-01-01

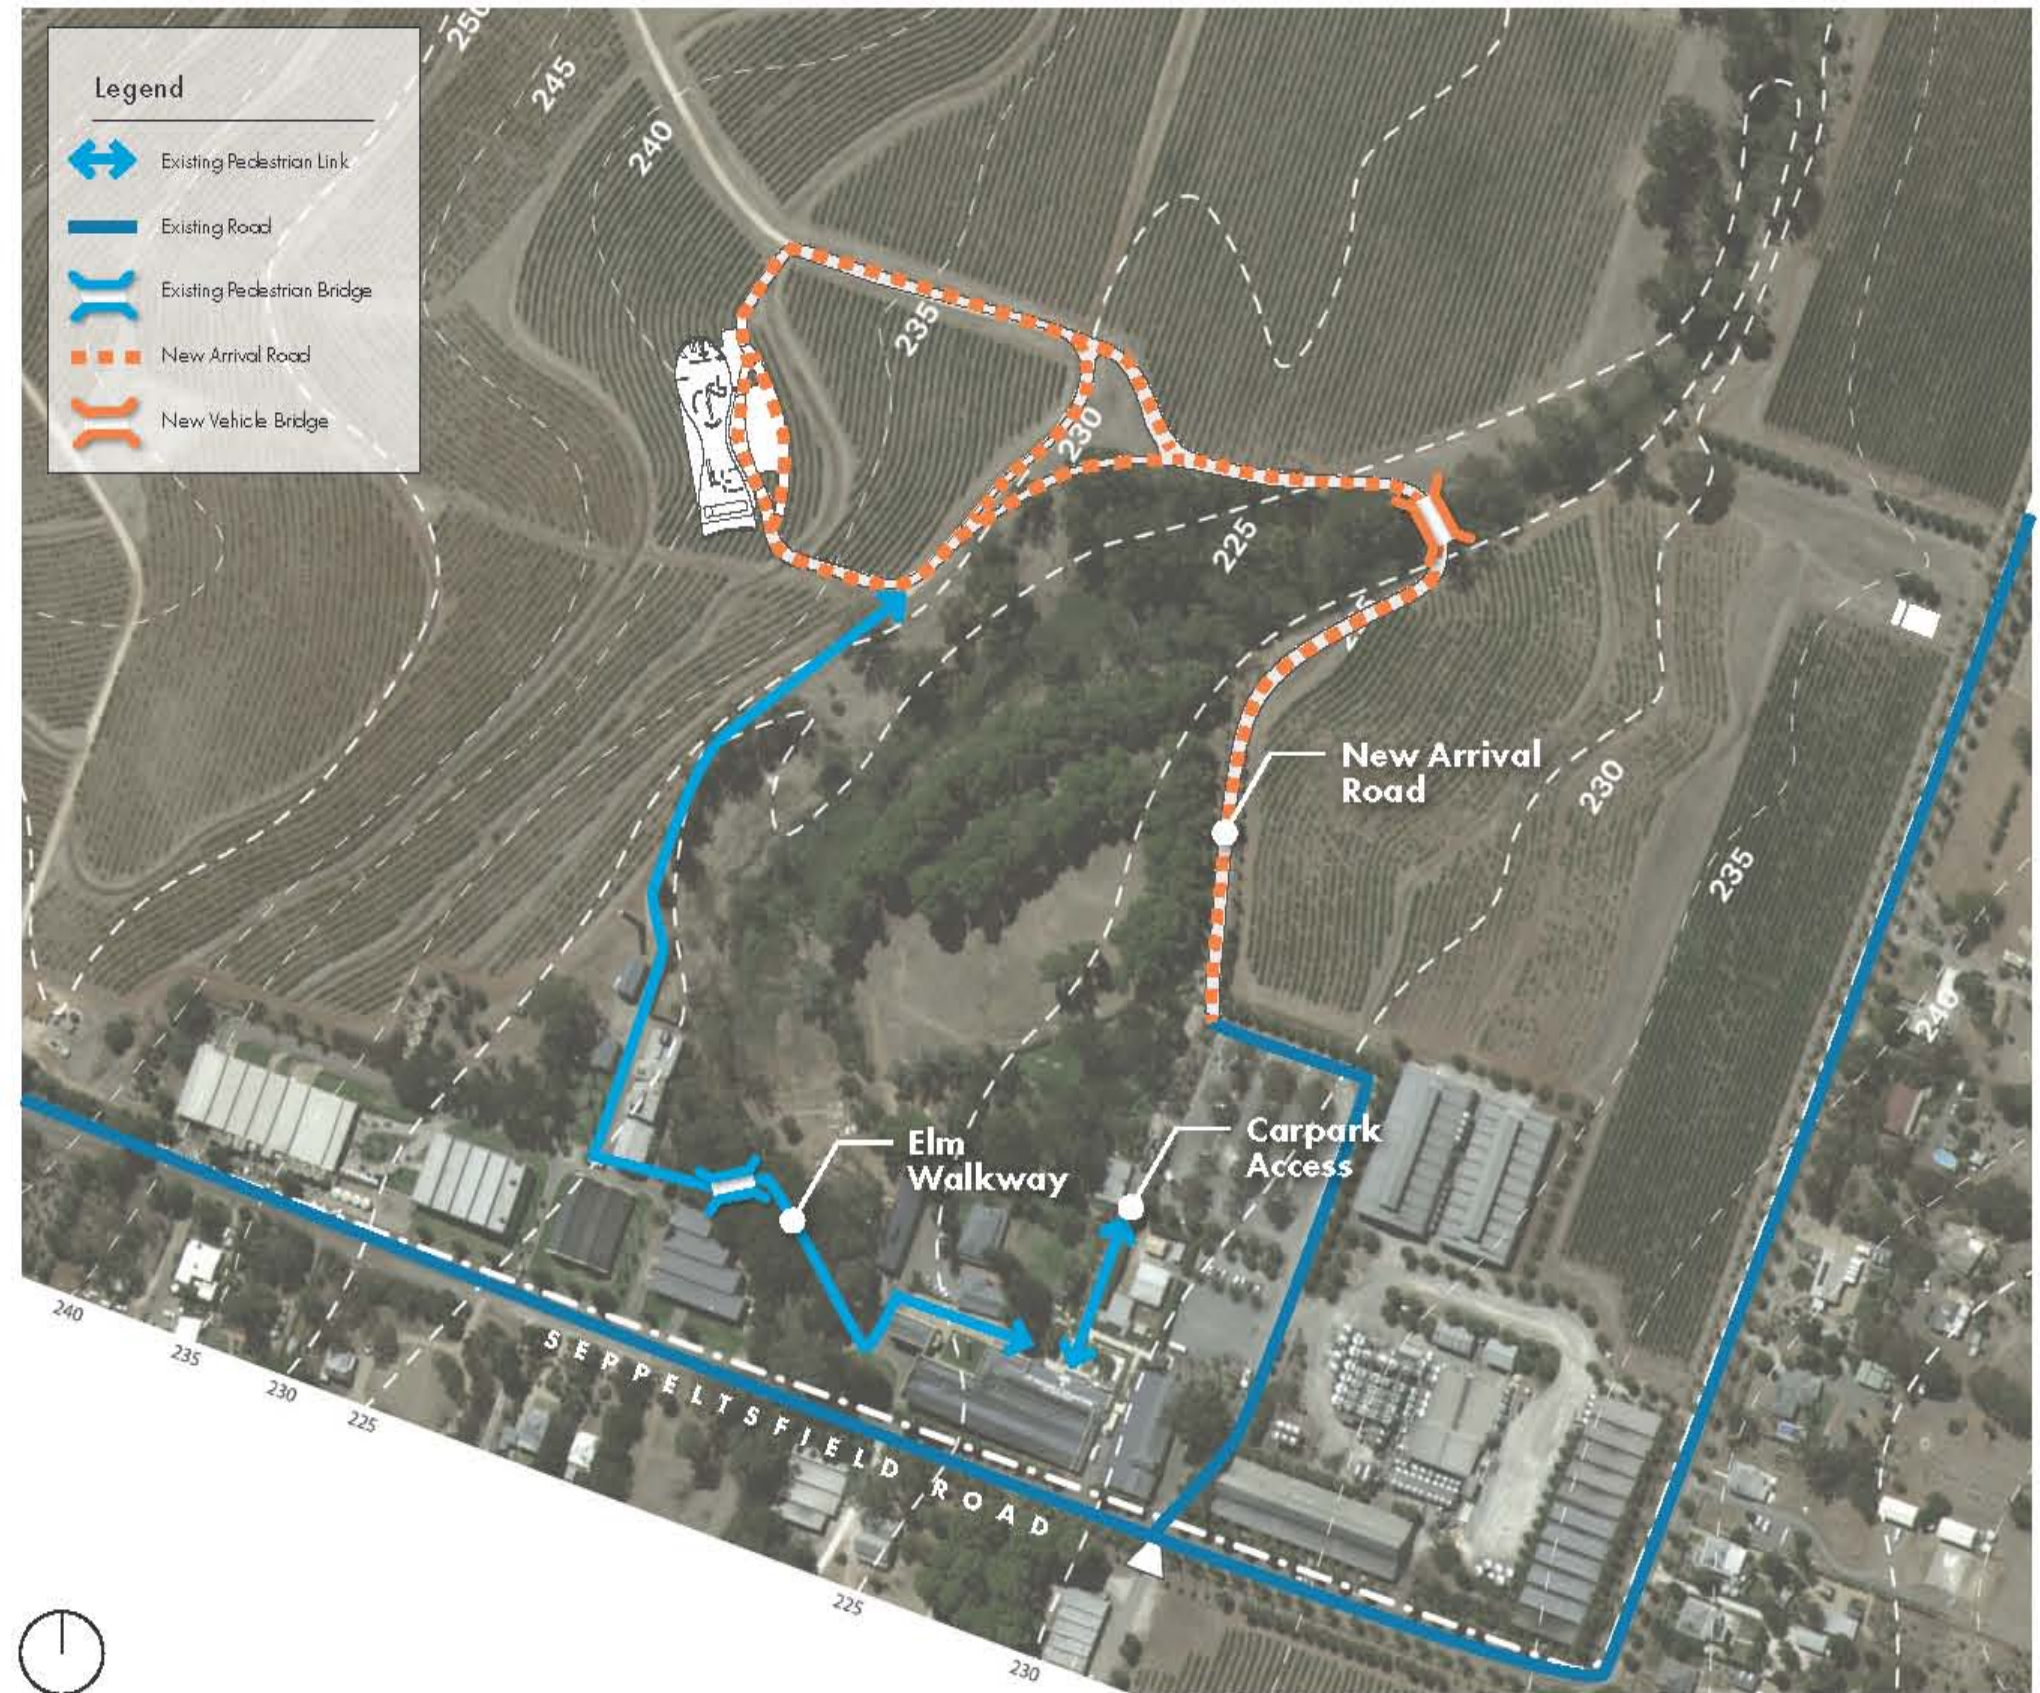
Key movements for visitors and staff currently link the adjacent old Gravity flow winery, cellars, Vinegar factory, bacon house and distillery. It is in this part of the winery where the cellar, restaurant and small artisanal businesses are collocated.

The main entrance for vehicles is via Seppeltsfield road to the south of the estate. The car park is situated behind FINO seppeltsfield, the cellar and the providedore. This is where access will be located between the historic avenues of palms once used as the main entrance by the Seppelt family.

There is an opportunity to link the winery with the new accommodation by establishing a network of meandering footpaths that interlink key historic buildings and formal path networks.

An opportunity exists for a scenic walking track beginning at the historic Elm Avenue, following the creek corridor and taking advantage of the open grassed spaces and shelter provided by the existing pine avenue. A significant River Red Gum provides a key landmark for a footbridge across the creek and meandering up a gradual slope, emerging through the vines to the new building and beyond where visitors could experience the views offered at the top of the hill.

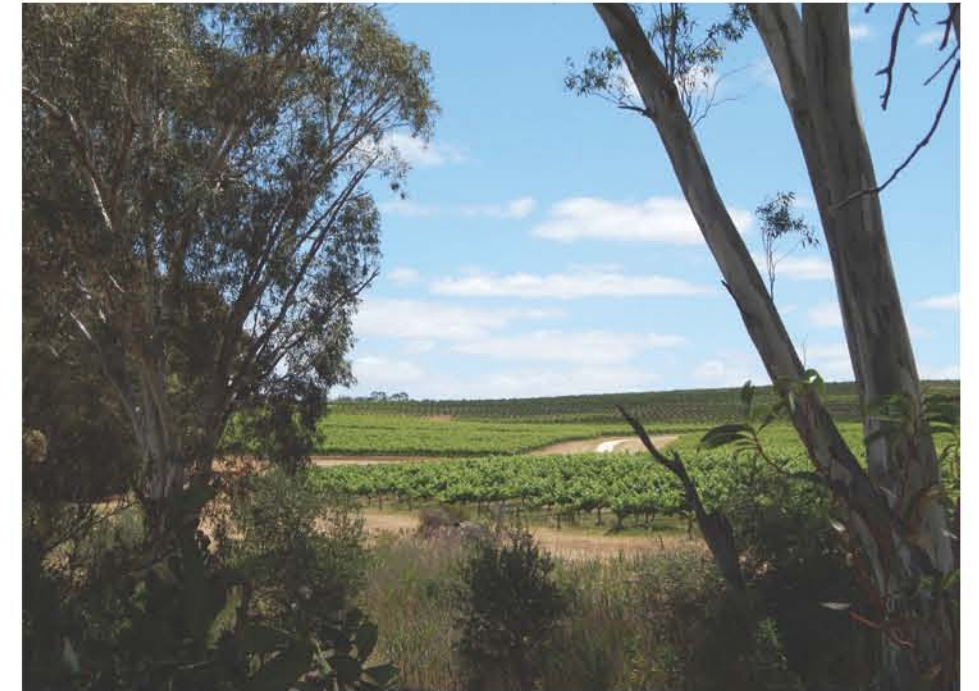
3 New vehicle bridge location, looking through Eucalyptus trees towards accommodation site.

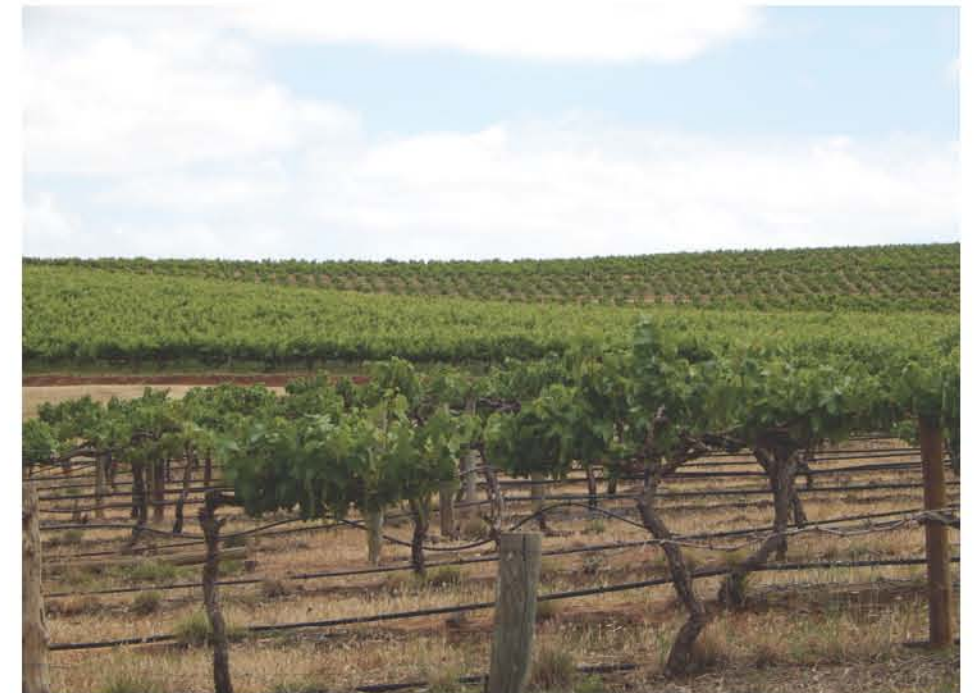
6 Vineyard layered along contours looking towards accomodation site.

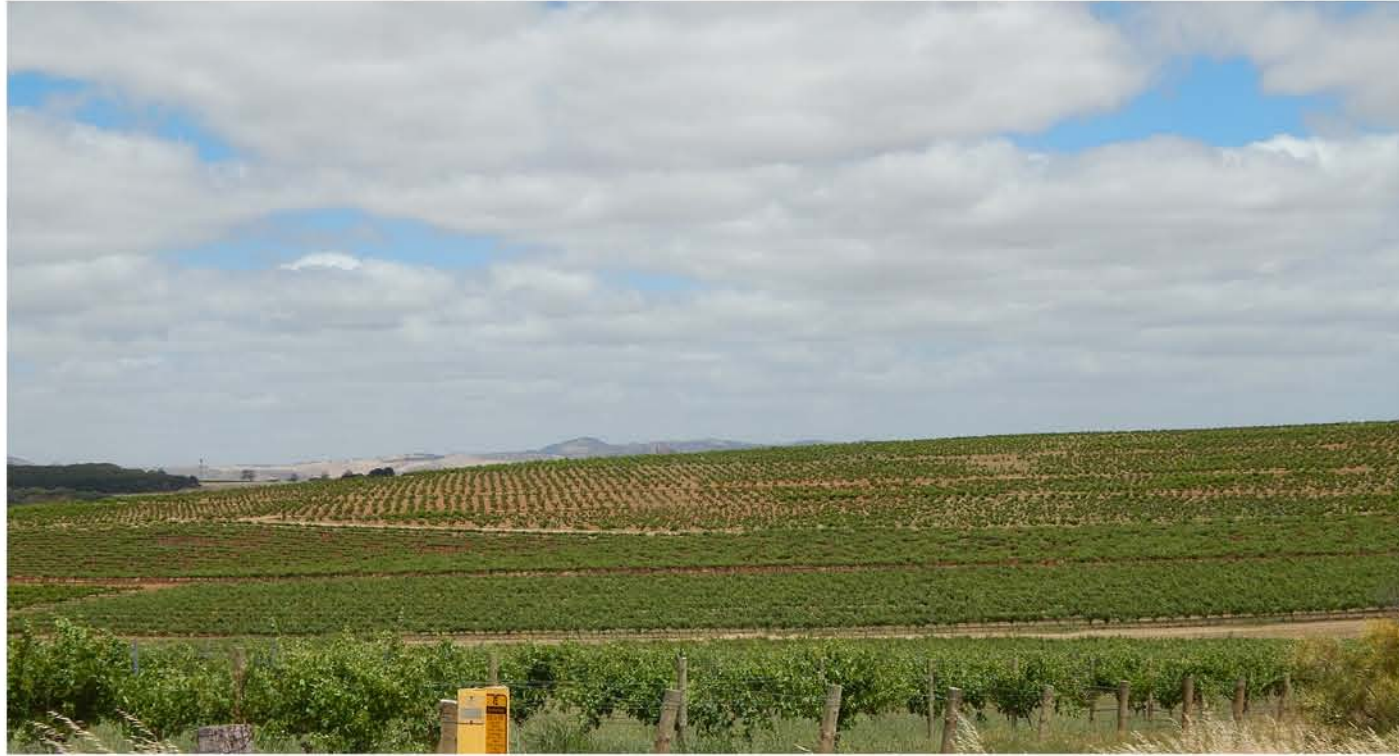
1

*Northern corner Radford Road and Seppeltsfield Road, looking South*

Estate contours, vines and topography assist to screen the building. Although not clearly evident in the image, the very top of the building may, in reality, be seen on the approach to the intersection of Seppeltsfield and Radford Roads. Drivers on approach may not have clear view of the building until further south of Seppeltsfield Road.

**Magnitude of change** - Low minor potentially neutral to existing

**Duration** – Long term

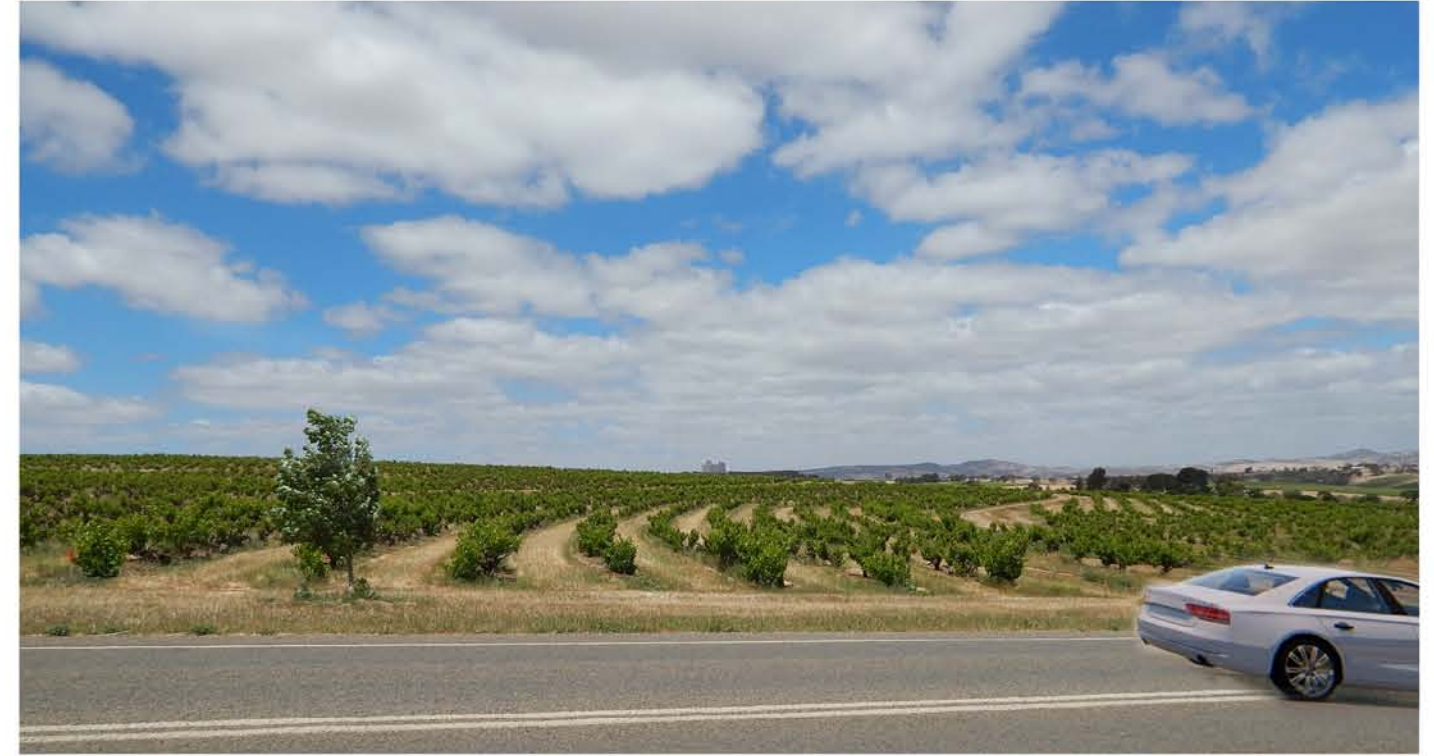
2

*Seppeltsfield Road West, looking east*

The top levels of the new building will be visible from the road but the magnitude of the visual impact will be marginal.

**Magnitude of change** - Low minor

**Duration** – Long term

Mitigation measure – increase frequency of street tree planting at road's edge to provide intermittent screening to the building.

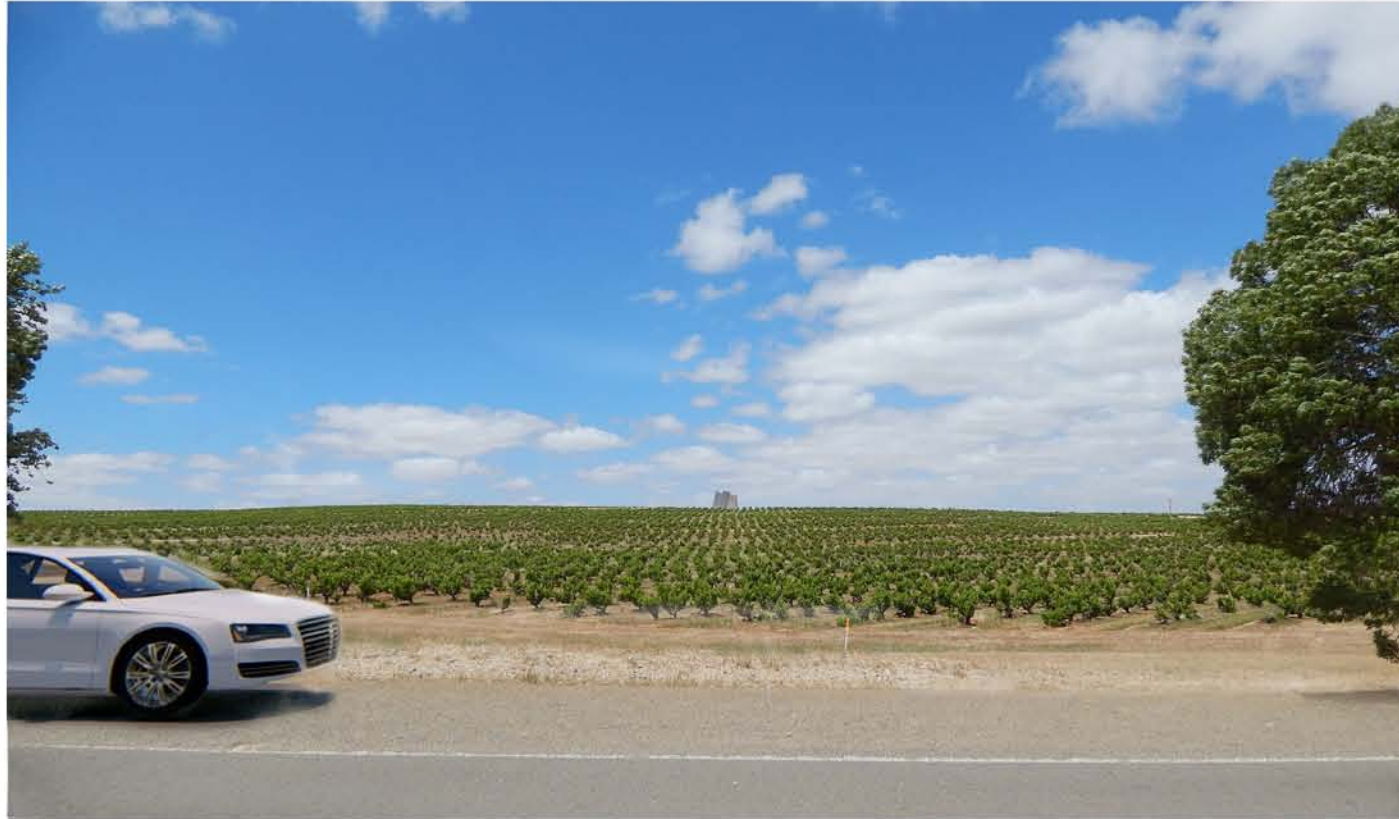
3

*Seppeltsfield Road South-West, looking east*

The top levels of the new building will be visible from the road and the magnitude of the visual impact from the road will be minor but noticeable. The building will be visible by road users at the intersection of Gerald Roberts Road and Seppeltsfield Road.

**Magnitude of change** - Low minor

**Duration** – Long term

**Significance rating** - low

Mitigation measure – increase frequency of street tree planting at road's edge to provide intermittent screening to the building.

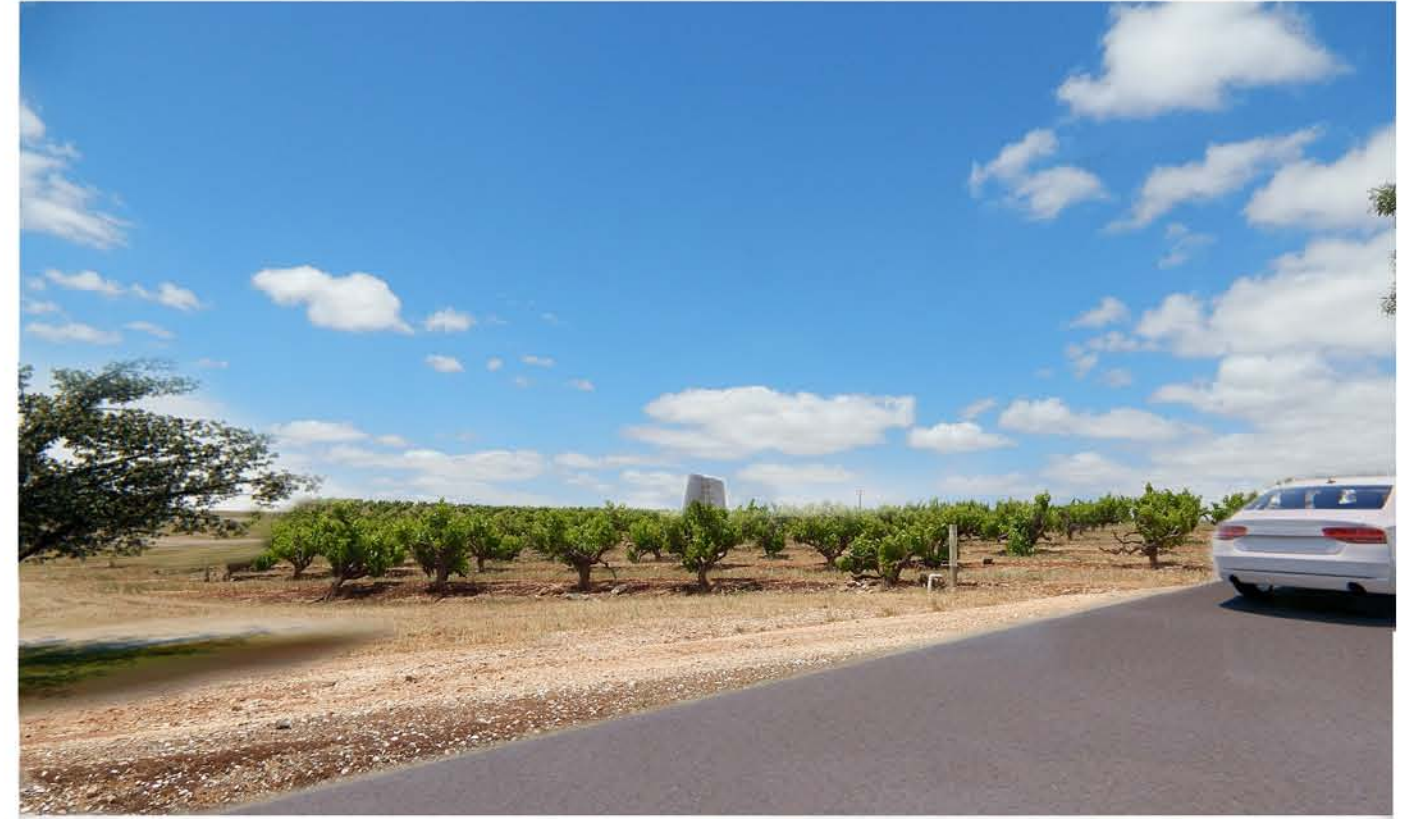
4

*Seppeltsfield Road South, looking north-east*

The top levels of the new building will be visible from the road and the magnitude of the visual impact from the road will be medium on approach to the entrance of the estate.

**Magnitude of change** - Moderate

**Duration** – Long term

Mitigation measure – increase frequency of street tree planting at road's edge to provide intermittent screening to the building.

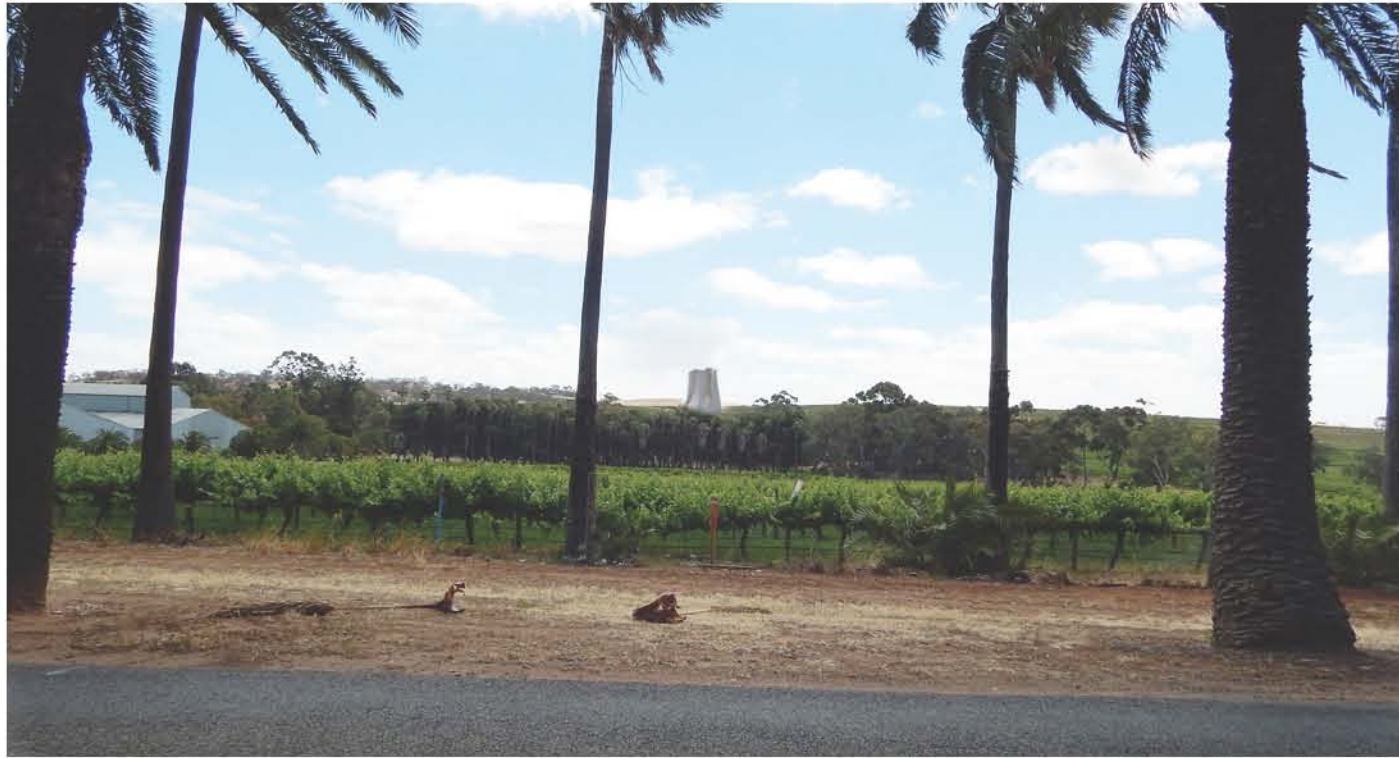
5

*Seppeltsfield Road east, looking west*

The top half of the new structure will be clearly visible from the road but will be intermittently screened by the heritage listed row of palm trees at the edge of the road. Partial screening to the lower half of the building is offered by vegetation along the creek corridor and access roads within the estate.

**Magnitude of change** – Moderate

**Duration** – Long term

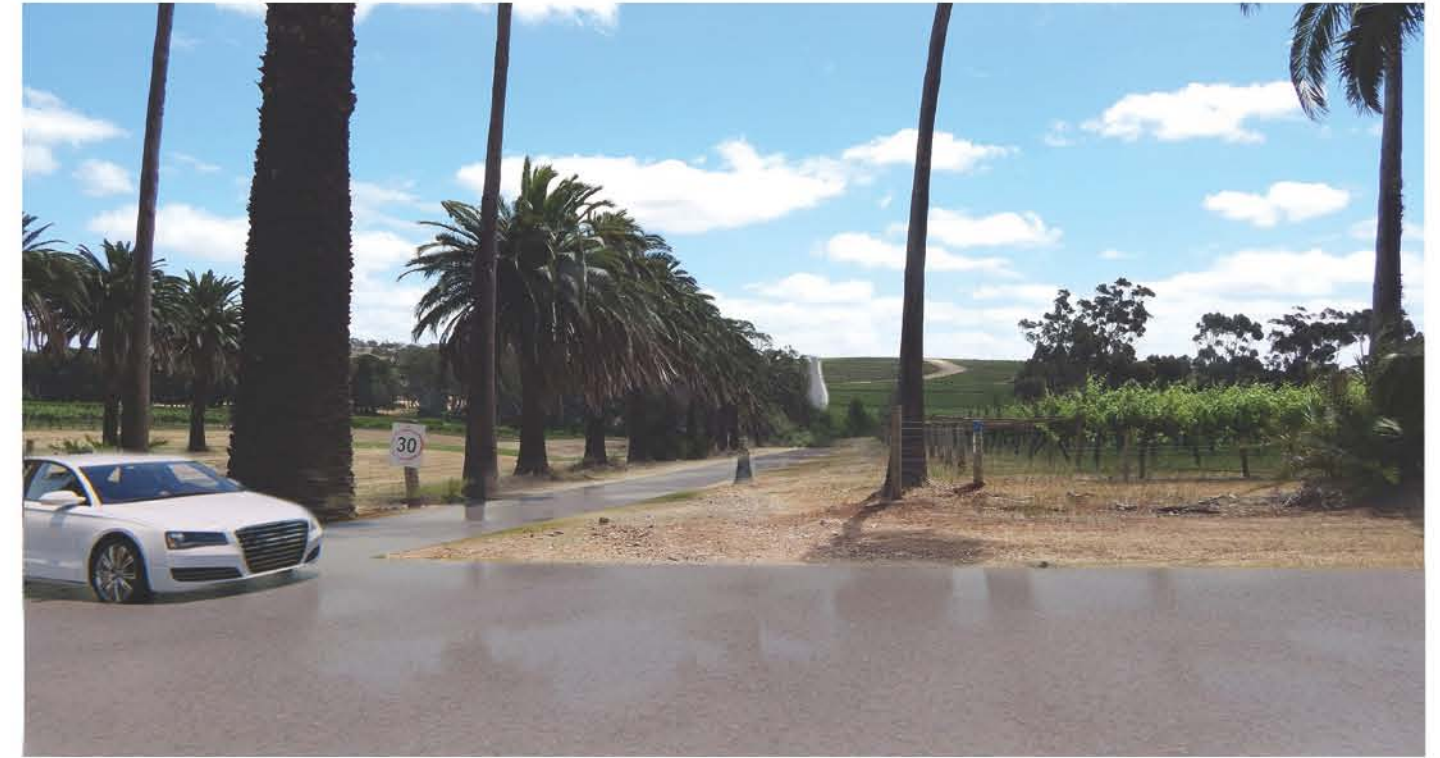
6

*Seppeltsfield Road east, looking west*

The top half of the new structure will be clearly visible from the road. Partial to moderate screening is offered by a high density of mature trees within the creek corridor and the heritage listed avenue of palm trees along the main road and access roads within the estate.

**Magnitude of change** – Moderate

**Duration** – Long term

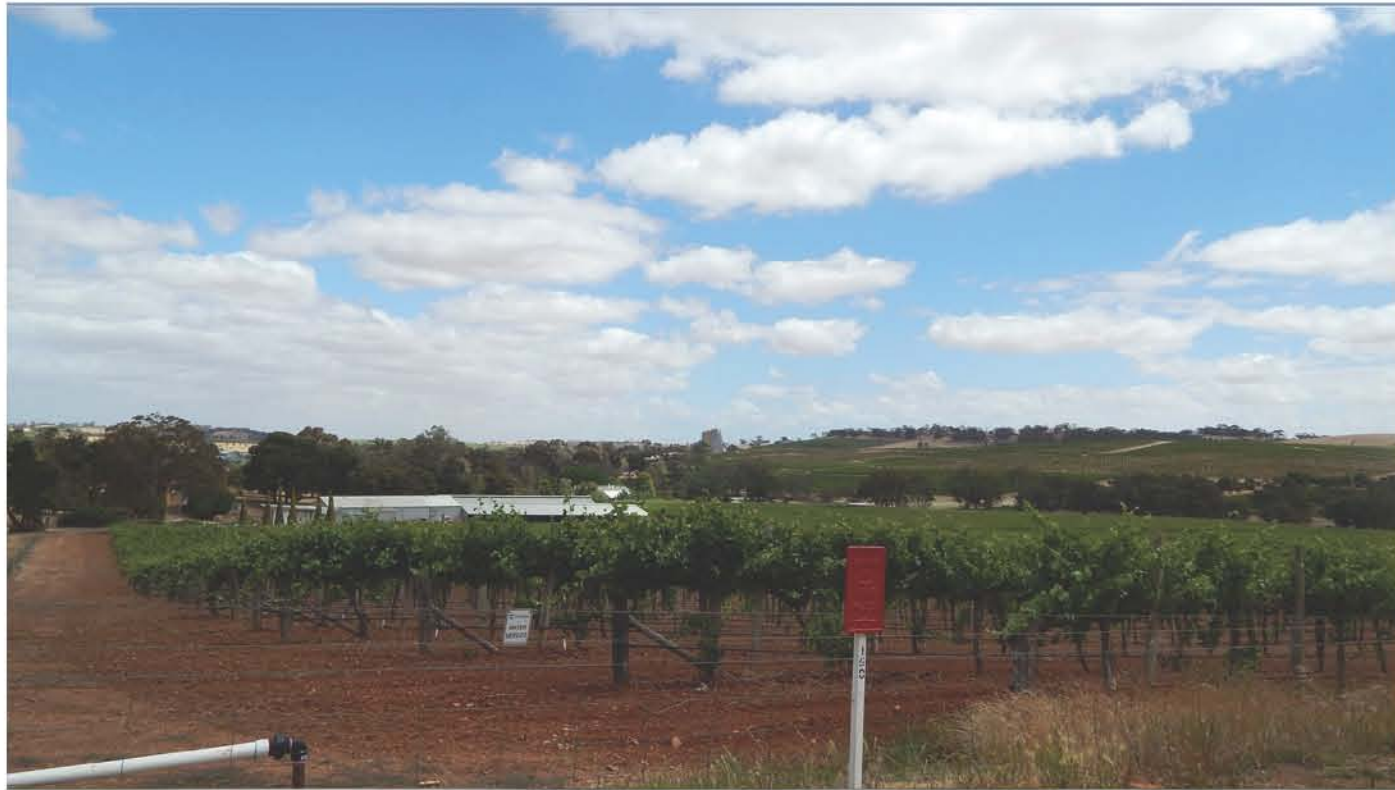
7

*Corner Radford Road and Peter Seppelt Road, looking West*

The top half of the new structure will be visible from the road. The lower half of the structure will be concealed behind the natural topography and surrounding vineyards. Partial screening is provided by the mature trees and vegetation along road corridors.

**Nature and Magnitude of change** - Low minor

**Duration** – Long term

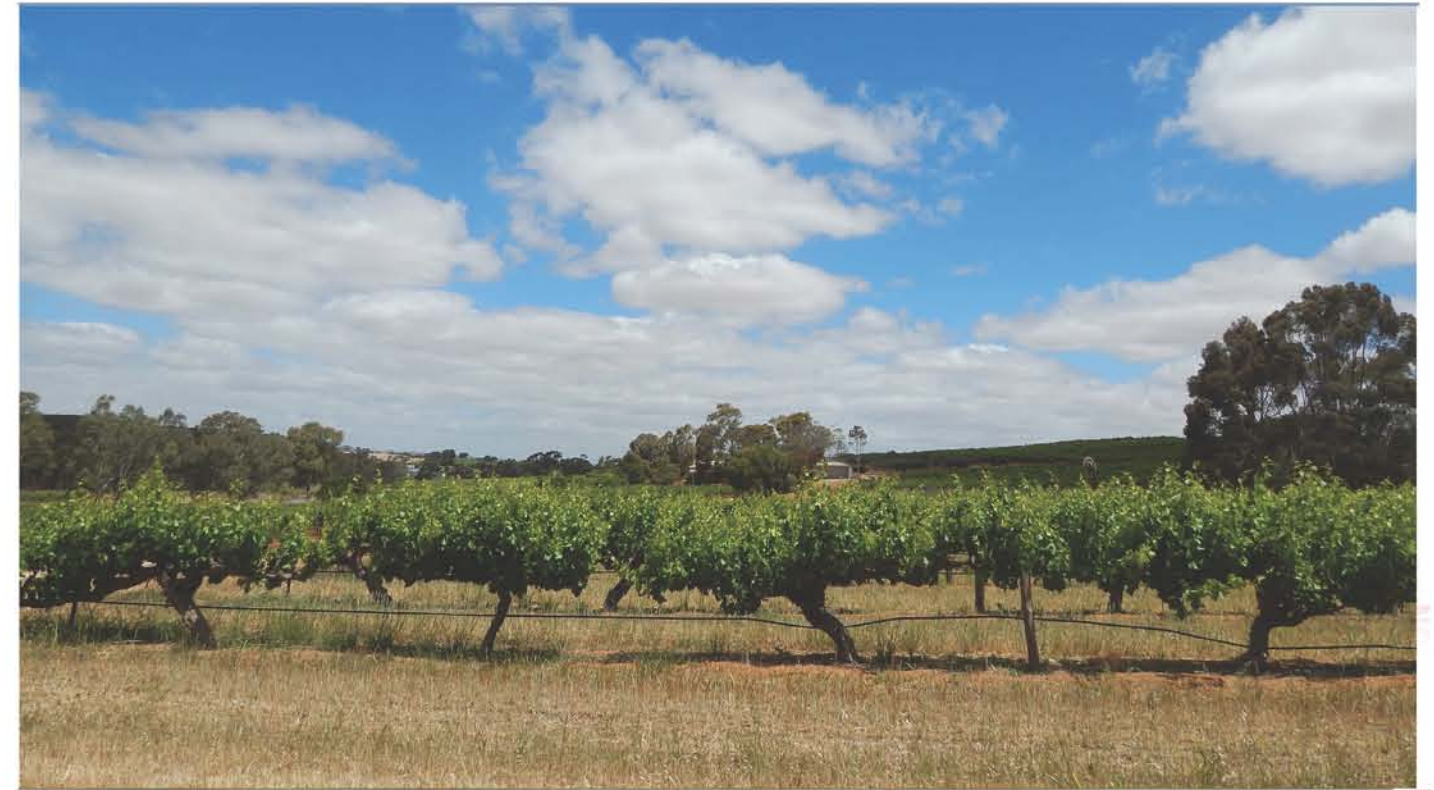
8

*Radford Road, looking south*

Low impact – The building is completely screened by vegetation

**Nature and Magnitude of change** - Low minor

**Duration** – Long term
